MIDDLE POND DAM
ME 00190

PHASE I INSPECTION REPORT
NATIONAL DAM INSPECTION PROGRAM

APRIL 1980

Identification No.: ME 00190
Name of Dam: Middle Pond
Town: York
County and State: York, Maine
Stream: Cider Hill Creek tributary to
the York River
Date of Site Visit: 16 November 1979

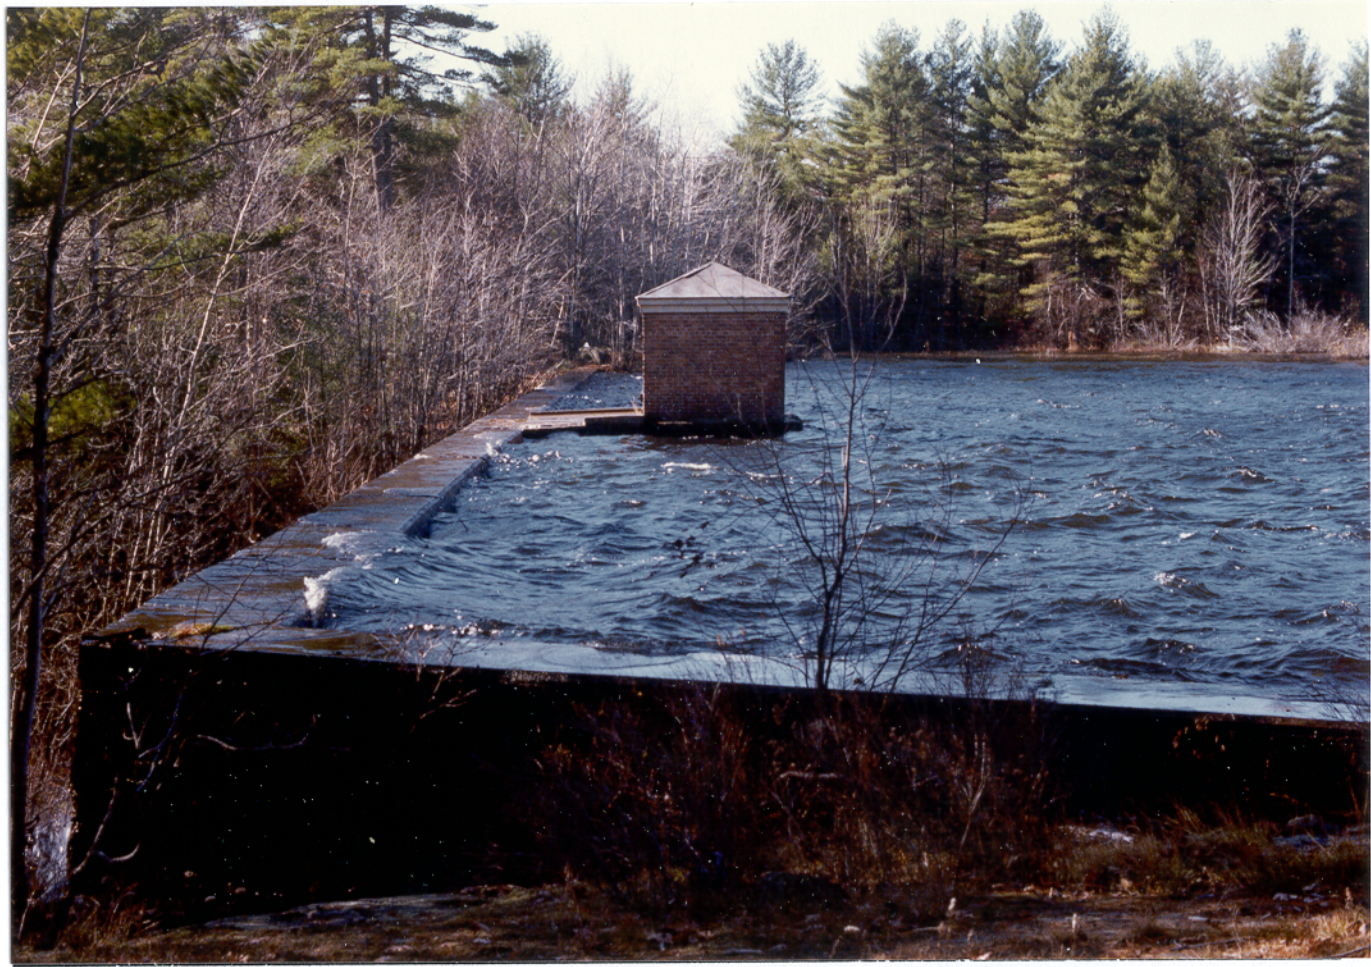
1. Overview of Middle Pond Dam from left side of dam

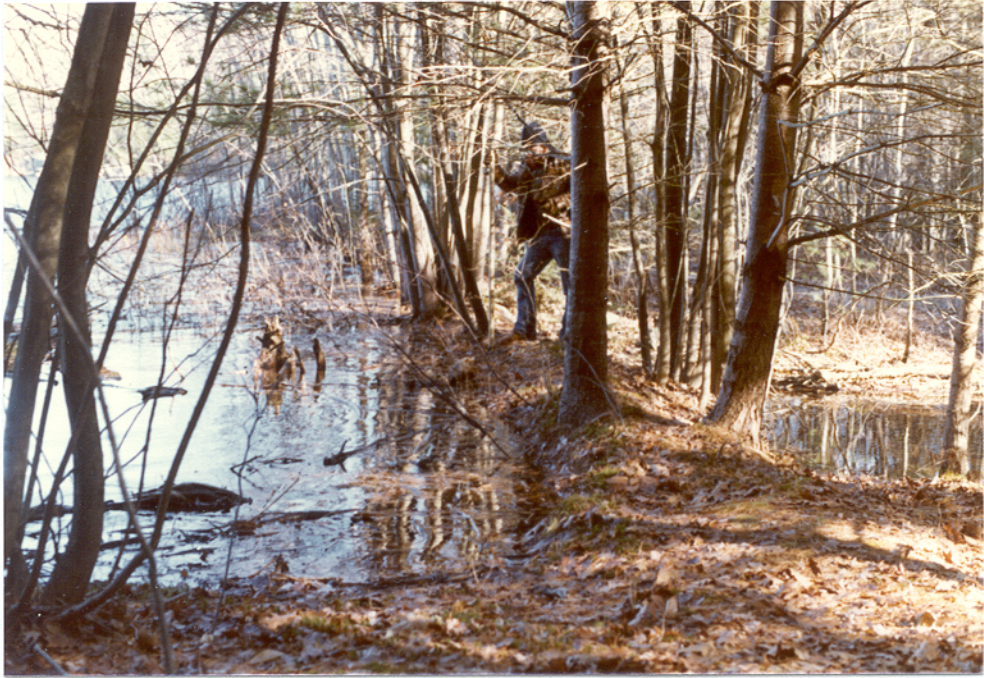
b. Dam. The 3-ft. high earth embankment, or dike, at the right side of the dam, Photo No. 2, is in satisfactory condition. The high reservoir level submerged the upstream slope and made examination of features on that side impossible. The crest is grown over with mature trees with exposed root systems, Photo No. 3. The horizontal and vertical alignment of the crest is indeterminate due to this condition. During the site examination water was ponded along the downstream side of the dike from recent rainfall and overtopping waves. Exposed bedrock occurs immediately downstream of the dike and at some locations is within 1 to 2 ft. of the crest elevation. The concrete core wall in the dike is believed to be bearing on rock.

2. Earth dike from right side of dam

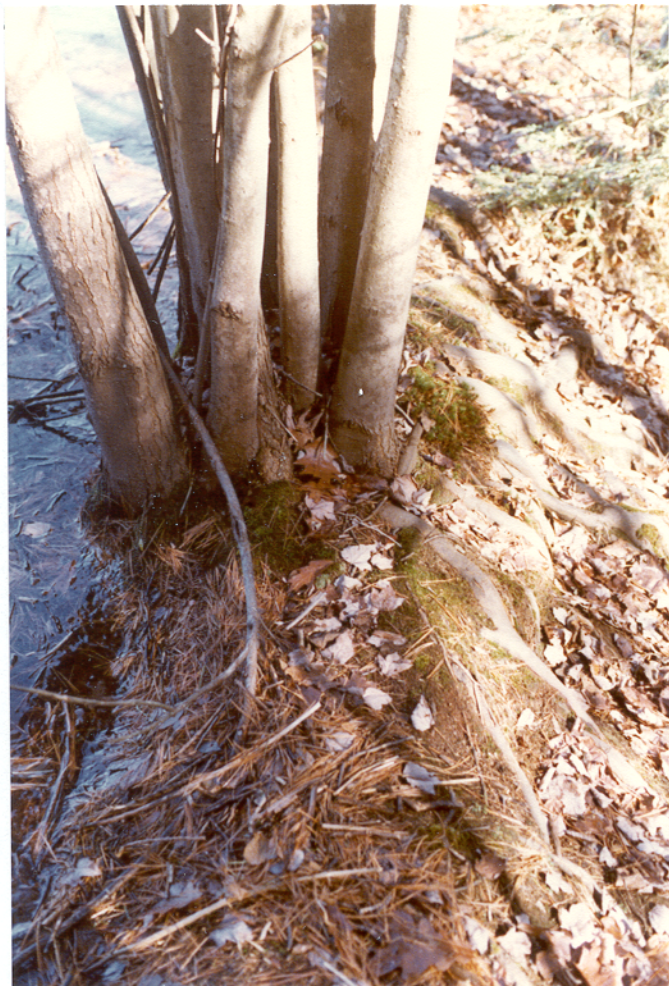
3. Mature tree growth over crest of earth dike

5. Cut and remove the trees located on the crest and slopes of the earth dike. Roots from these trees could damage the concrete core wall and/or interpenetrate the cracks of the bedrock initiating a failure in this structure. Also, if trees on the dike were to be blown over the root systems would probably cause considerable damage as they were uprooted.

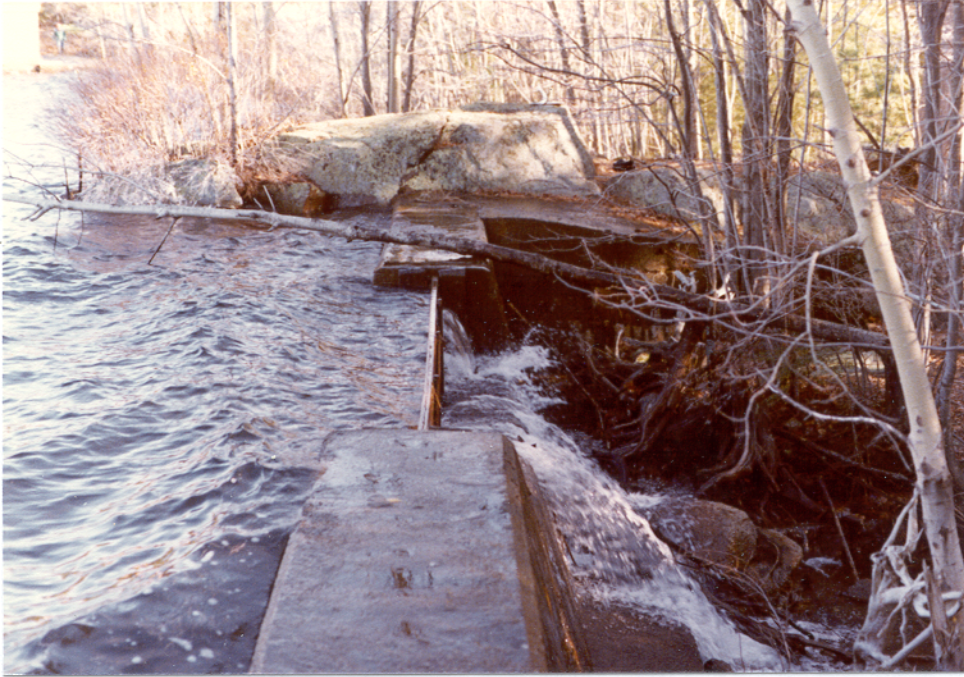
The concrete dike, Photo No. 4, is in fair to good condition. Efflorescence, spalling and erosion of the concrete is apparent but considered minor. The day of the site examination water was leaking through the flashboards as would be expected from the high reservoir level. The flashboard supports were rusted but both boards and pins appeared serviceable. Immediately downstream of the spillway section there are many trees, alive and dead, obstructing the discharge area, Photo No. 5.

4. Alignment of concrete dike and spillway

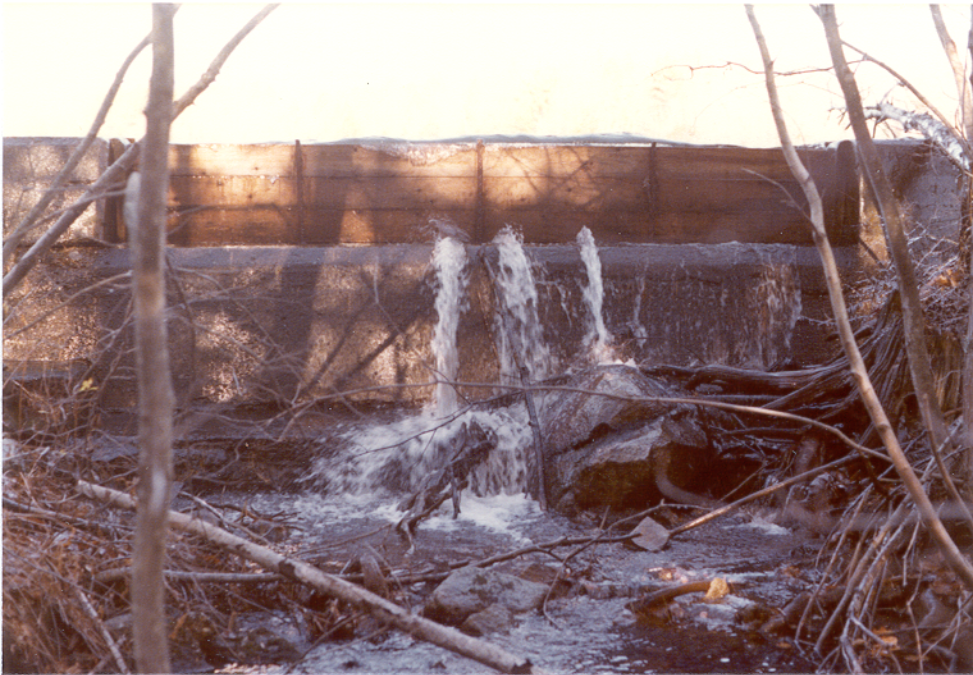
5. Spillway, with water overtopping flashboards, and discharge area

1. Remove the spillway flashboards so as to provide 2 ft. of freeboard during dry weather. Flashboards should not be replaced pending the results of the recommended hydrologic-hydraulic studies.
2. Repair eroded and spalled concrete areas at the masonry dam and concrete dike. All deteriorated and weak concrete should be removed prior to patching the concrete.
3. Provide a safe means of access to the gate house and into the gate chamber when overtopping discharges occur at the dam. Consideration should be given to the construction of a raised walkway with railing across the top of the dam.
4. Clear trees and brush for a distance equal to twice the adjacent height of the structure immediately downstream of the masonry dam and dikes. Clear trees and brush from the spillway discharge area and downstream channel.

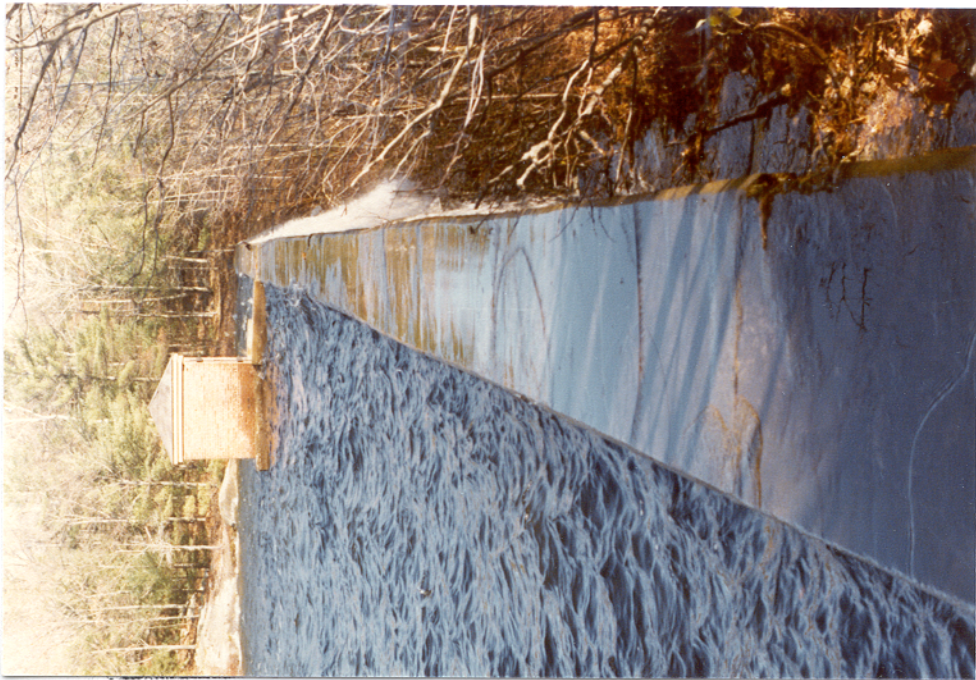
The horizontal and vertical alignment of the composite stone and concrete dam was fair, Photo No. 6. A detailed determination of the masonry condition was not practical during the site examination due to the wind driven waves breaking over portions of the dam, Photo No. 7. However, the condition of the masonry visible, Photo Nos. 8 and 9, was generally fair to poor with efflorescence and seepage observed at many locations. Concrete spalling and

6. Alignment of composite masonry dam and gate house

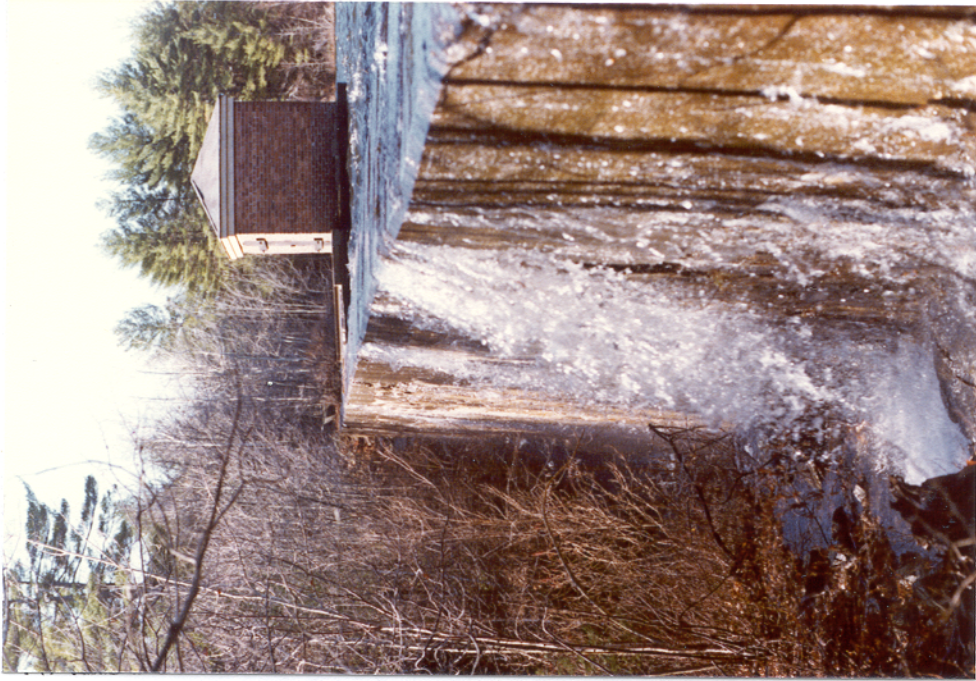
c. Appurtenant Structures. The gate house was not readily accessible because the entrance is kept closed by two large boards, Photo No. 7, bolted to the brick wall of the gate house. Without the appropriate tools, and keys to the gate house door, an attempt to gain access was not made. The Superintendent of the Kittery Water District, present during the site examination, reported that the gate chamber was last drained and inspected during 1977. The exterior of the gate house appeared to be in good condition, Photo Nos. 1 and 6. Water was reportedly being withdrawn from the pond through the gate house transmission mains during the inspection.

7. Wind driven waves overtopping masonry dam; note boarded gate house entrance

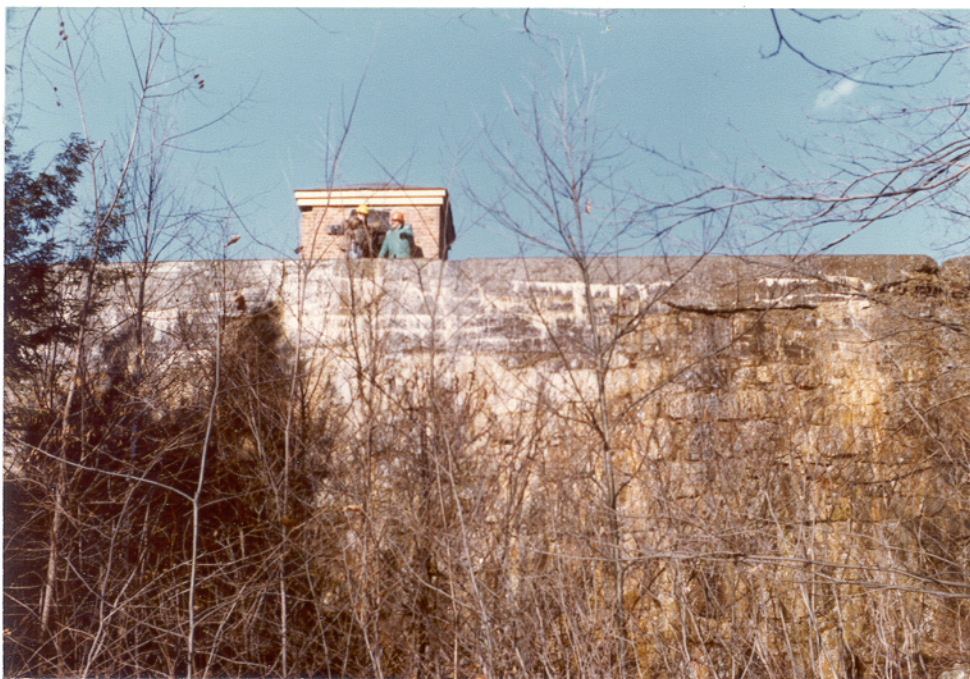
8. Maximum section of dam, downstream

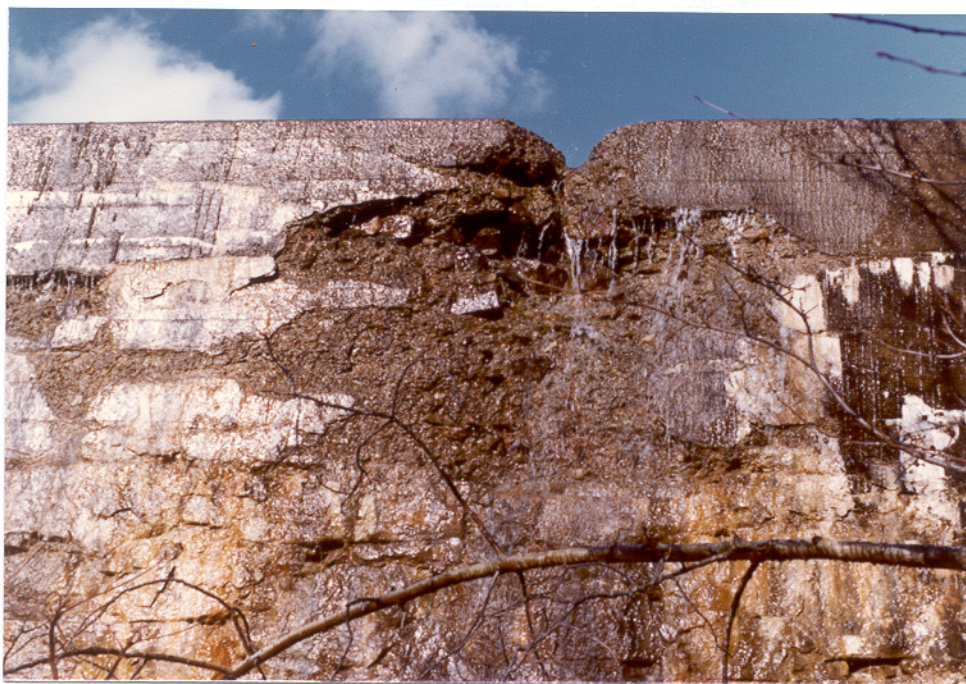
deterioration were typically worse at the joints of the concrete cap and at the stone-concrete masonry contact. Though there were numerous voids and spalling of the mortar between the stones of the older masonry, no failed areas of fallen stone were apparent.

9. Efflorescence and deterioration of concrete
at top of dam

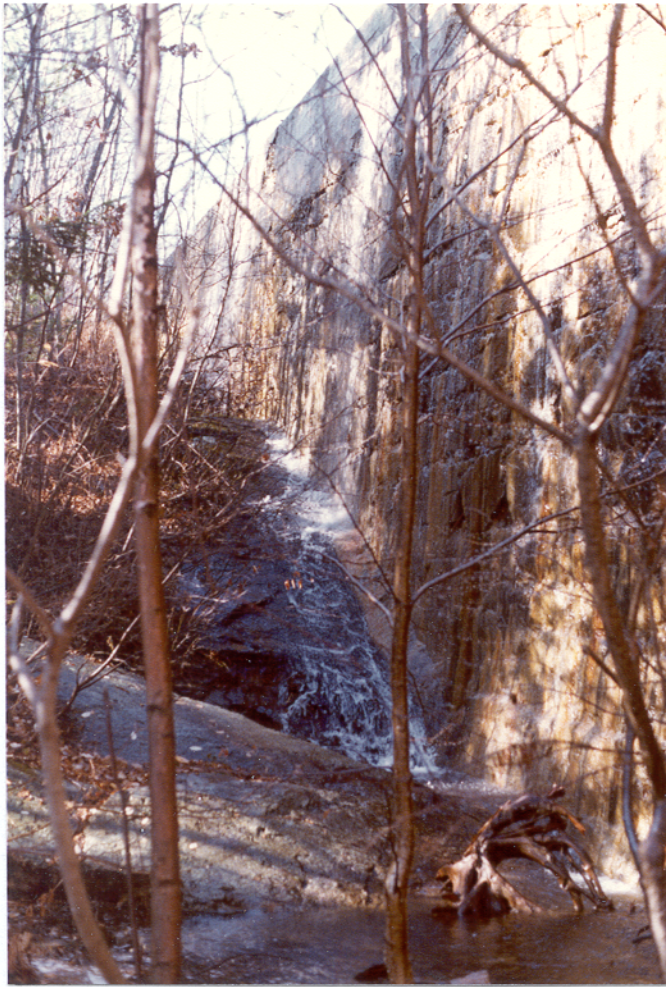
10. Overtopping water
flowing to down-
stream channel
along toe of
dam

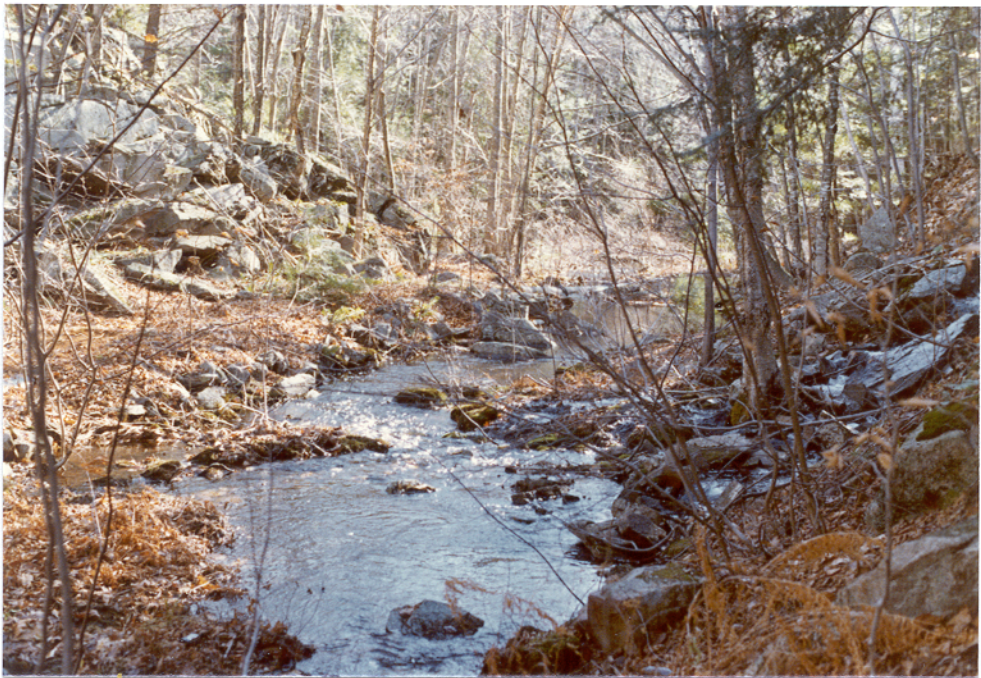
AREA EVALUATED	CONDITION
c. <u>Discharge Channel</u> General Condition Loose Rock Overhanging Channel Trees Overhanging Channel Floor of Channel	 Poor - rocky and wooded stream None observed Many trees and brush Rocky

11. Downstream channel
